Technical Series

99-104

HIGH-RISE APARTMENT REPAIR NEEDS ASSESSMENT IN THE FORMER CITIES OF TORONTO AND YORK

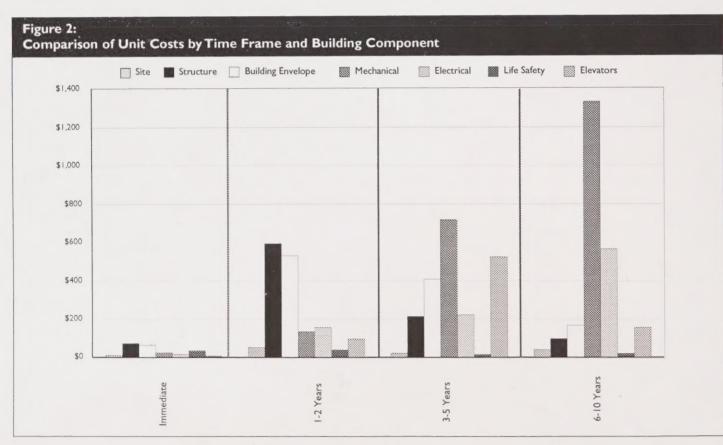
For each parameter, the cost of building repair or replacement was determined over the next 10 years on a per-unit basis (See Figure I). A rating system was calculated for each building to gauge its condition in terms of repair urgency and safety/usability. Costing methodology (most cost-effective repair) and sampling procedures were also elaborated and pre tested.
